IOC / OdinAfrica / GLOSS

Technical Visit to Madagascar and Comoros

28 April to 10 May 2006

Frédéric SIMON
Surveyor
France

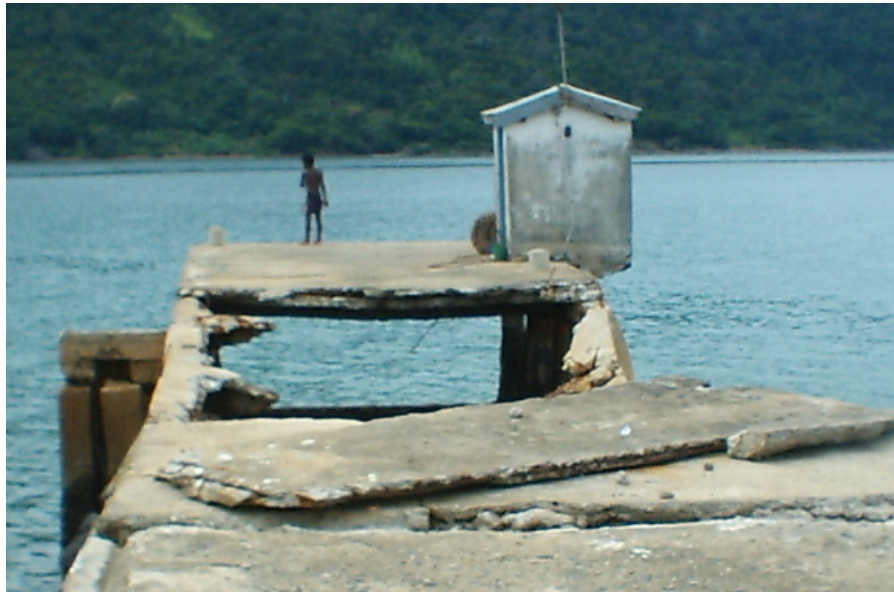
The tide gauge (floating sensor OTT R16 model) was operational until May 2003. After a series of problems, the tide gauge was stopped in June 2003. After looking at the tide records, it appears that the floating sensor was blocked in the stilling well tube. The bottom of the stilling well is now buried in muddy sand. The tide gauge equipment has been removed from the tide house. The power supply of the tide house has been cut and the tide pole has disappeared.

The pier was seriously damaged by the storm GAFILO in 2004. It must be rebuilt before any tide gauge installation. (See figure 1 below)

Figure 1 : Pier of CNRO (damaged by GAFILO storm) with the tide gauge hut

- the pier of CNRO must be rebuilt before the construction of a new tide house.
(This may be done this summer according to the director of CNRO)
- the power supply for the tide gauge must be maintained permanently. Solar panels are likely not sufficient to allow a tide gauge to function during several hours of power cut.

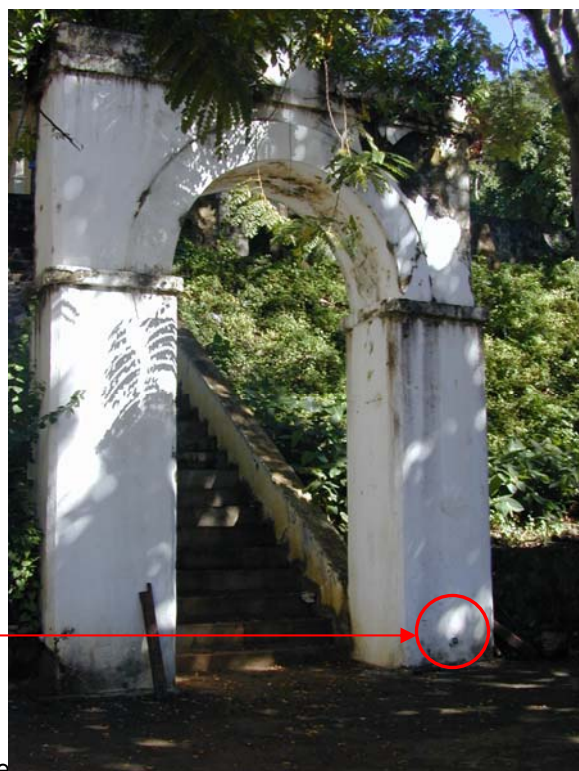
A tide bench mark has been located in the gate of the old entrance of CNRO. (See figure 2 at right)

It's a reliable TBM embedded by the French Hydrographic Office and can be used if needed.

The distance between the BM and the tide house is about 80 metres, and not too long for classic levelling.

Figure 2 : French Hydrographic Office BM

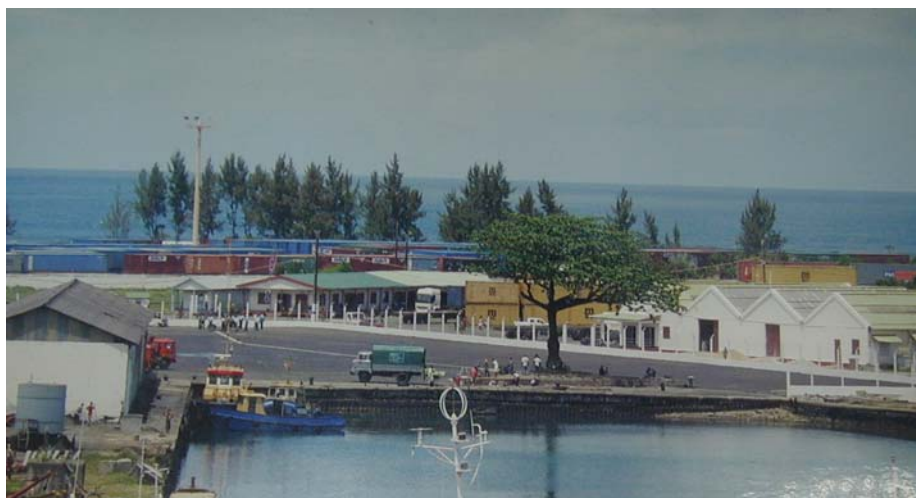
The old tide gauge installations (tide house, tide well and associated BM) have been destroyed and replaced by a fresh new car park in 2005 (see figure 3 below).

Figure 3 : The location of the old tide gauge is (approximately) just behind the van.

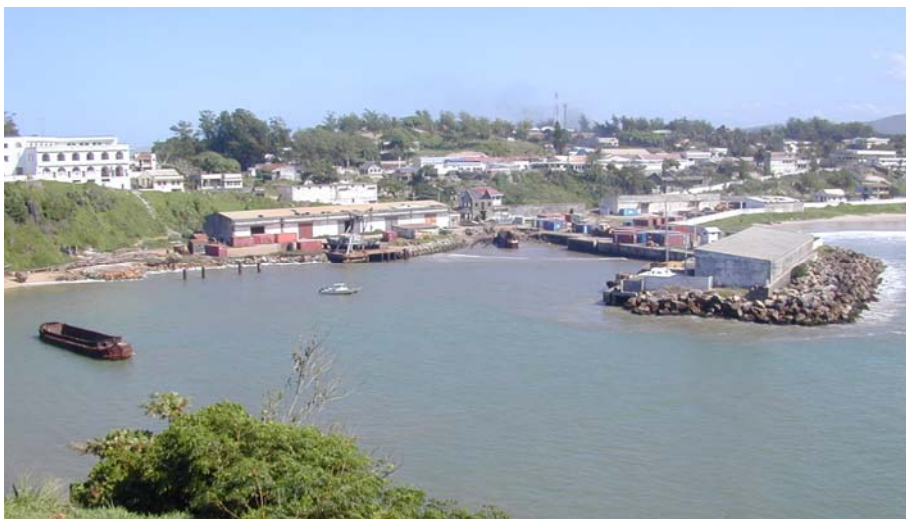
The port of Fort-Dauphin is very small (see figure 4). Merchant activities are practically nonexistent. The reasons are :

- the approaches of the port via Dauphine bay are extremely dangerous because of existence of many wrecks
- a steady (and sometimes heavy) swell sweeps across the harbour
- no industry in the vicinity of the town
- access roads to the town are in very bad conditions

A visit of the port installations was organized with the port master. There isn't any guard to ensure the security of the port. Any gate also. Many damaged containers, neglected within harbour, are used by poor people as habitation.

Figure 4 : View of the Fort-Dauphin port.
