Intergovernmental Oceanographic Commission

OTT HYDROSENSOR SITE UPDATE REPORT

SONARA (CAMEROON)

15-18 December 2008

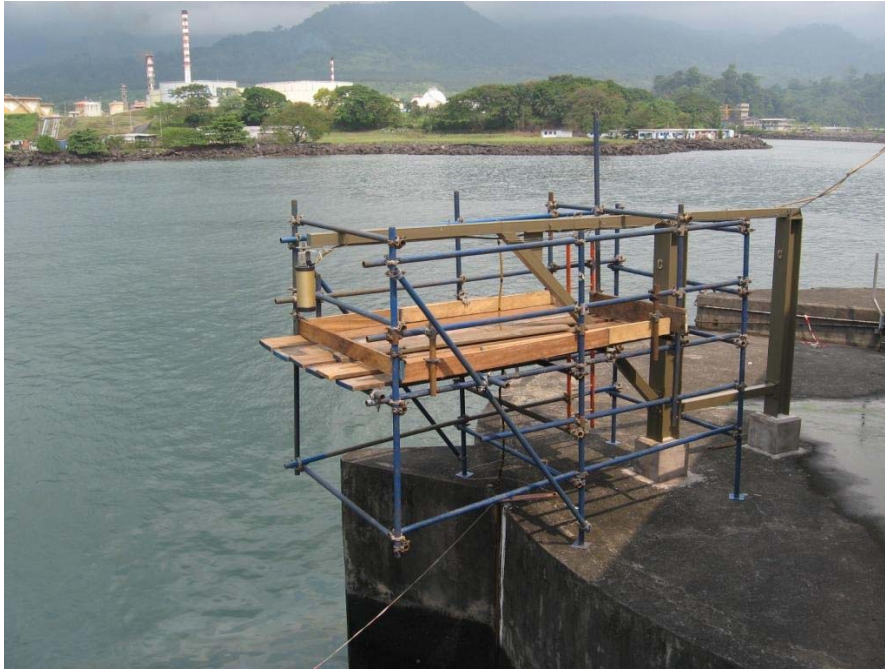
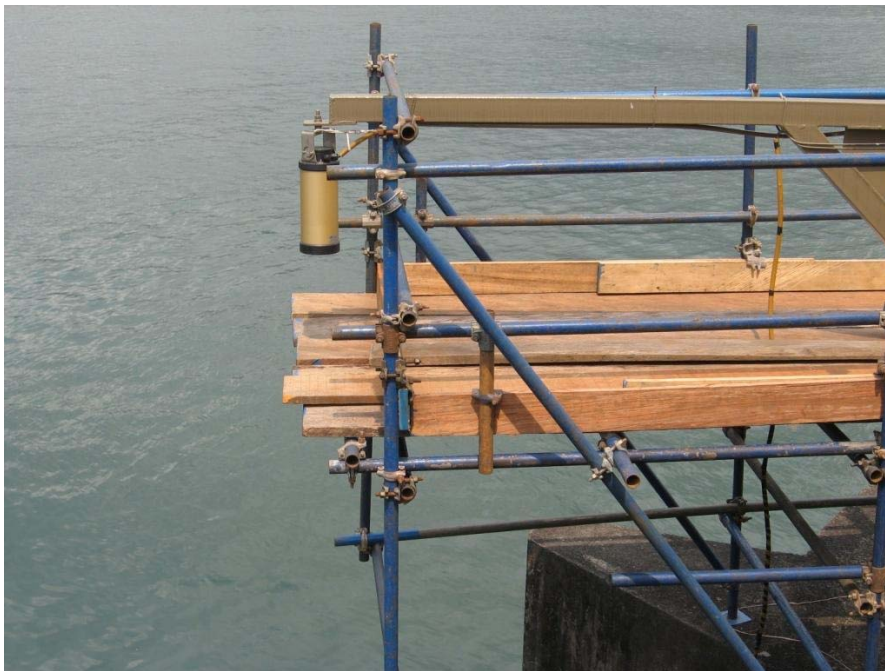
APPENDICE A : ADDITIONAL PICTURES

Another problem occurred later due to the installed scaffolding around the radar sensor. See Appendix A.

The scaffolding has been removed. Radar sensor works correctly.

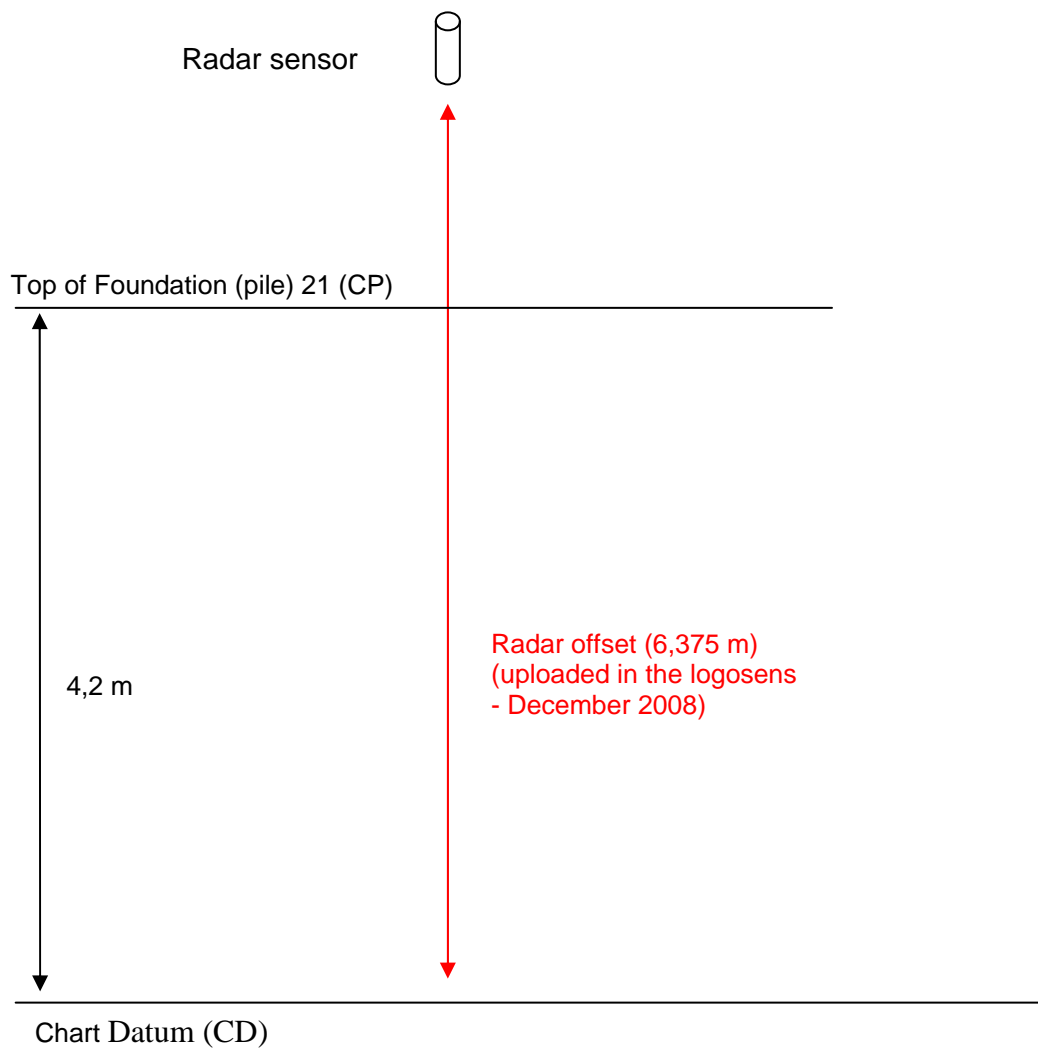
APPENDICE B : VERTICAL DATUMS SCHEMA

The original plans from the civil engineering from BOUYGUES company which constructed the SONARA jetty were examined. They date back to 1979-1980. These documents confirm that the top of the pile 21 is 4,2 m above the chart datum (CD). No more recent information regarding the CD could be found.

A mistake, an error of drawing, was integrated in the drawing given to me during my first visit. Because of that, the pressure sensors are 60 cm too low !

- The pressure sensors were installed with an approximate height above the chart datum (CD). It will be necessary to move up these sensors according to the true value of CD. The support of the pressure sensors are fastened only on its top part; a new intermediate binding must be added on the pile side when the pressure sensors will be at good position. Two days of work are necessary to complete the job,
- To put in place a system against floating scraps (below the radar sensor)
